James S. Muraoka

Technical Note N-1263

EFFECT OF BOTTOM SEDIMENT CONTAINING  
HYDROGEN SULFIDE ON MATERIALS - PART I

NAVAL CIVIL ENGINEERING LABORATORY  
Port Hueneme, California 93043

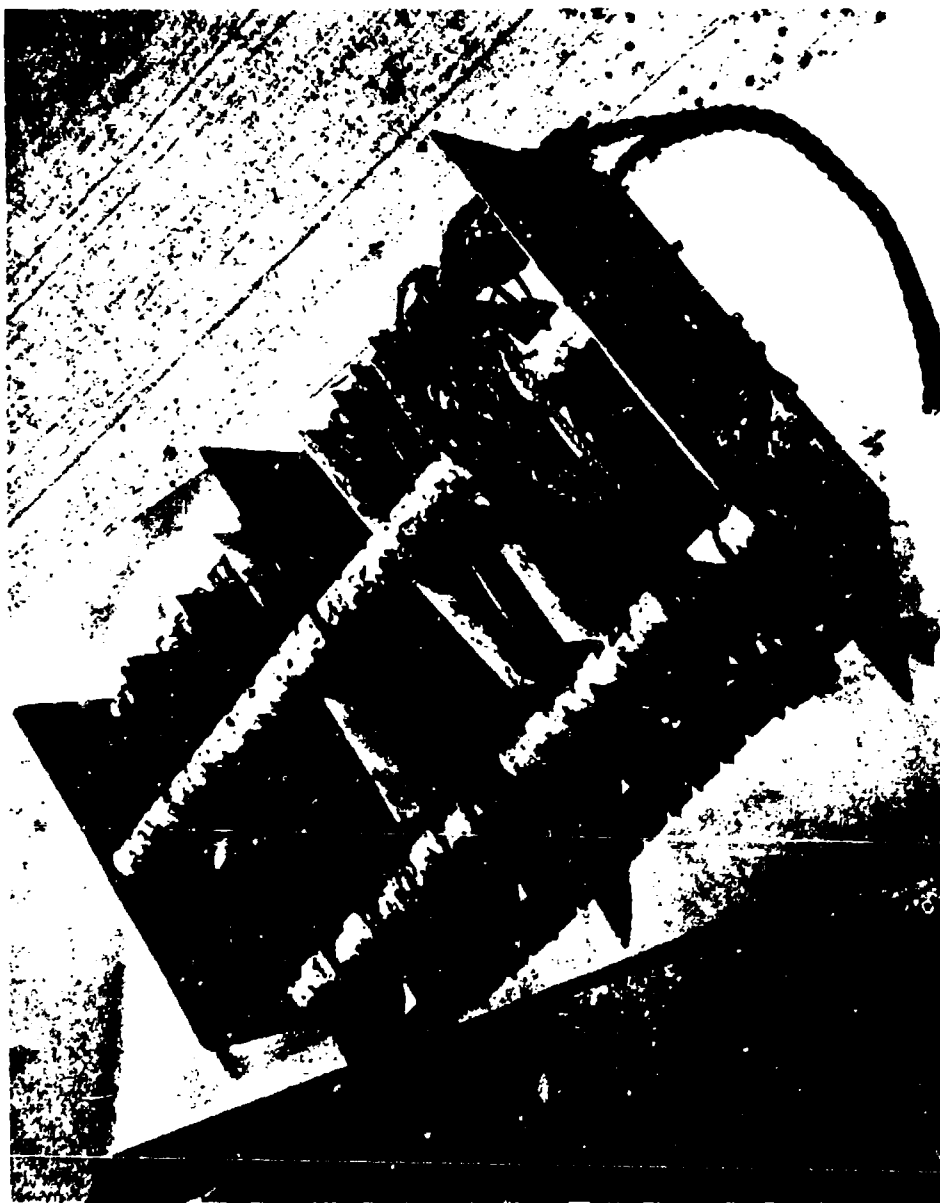
The titanium rack with materials which has been exposed in the bottom sediment for a period of one year was recovered by divers during the month of September 1972 (Figure 4). The depth into which the materials were buried in the sediment can be determined by the end plate of the titanium rack (Figure 5). There was light fouling growth attached to the recovered materials. The sessile organisms found attached to the materials were composed mostly of encrusting bryozoa (several species), calcareous tubeworms, and rock oysters. These fouling organisms are not adversely affected by living in a seawater environment containing hydrogen sulfide and low dissolved oxygen concentration. After the plastic panels (6 x 12 inch) were cleaned of marine growth, hardness and moisture absorption tests were conducted. The results of these tests are presented in Table 1. The hardness test was conducted over two different sections of the surface of the plastic panels - the section which was buried in the mud and the section which was exposed to seawater above the mudline. The two sections would be distinguished by the discoloration present in the plastic panel. For example, the section of a PVC panel (grey)

Figure 4. Titanium rack with materials recovered after one year exposed (partially) in bottom sediment of Port Hueneme Harbor.

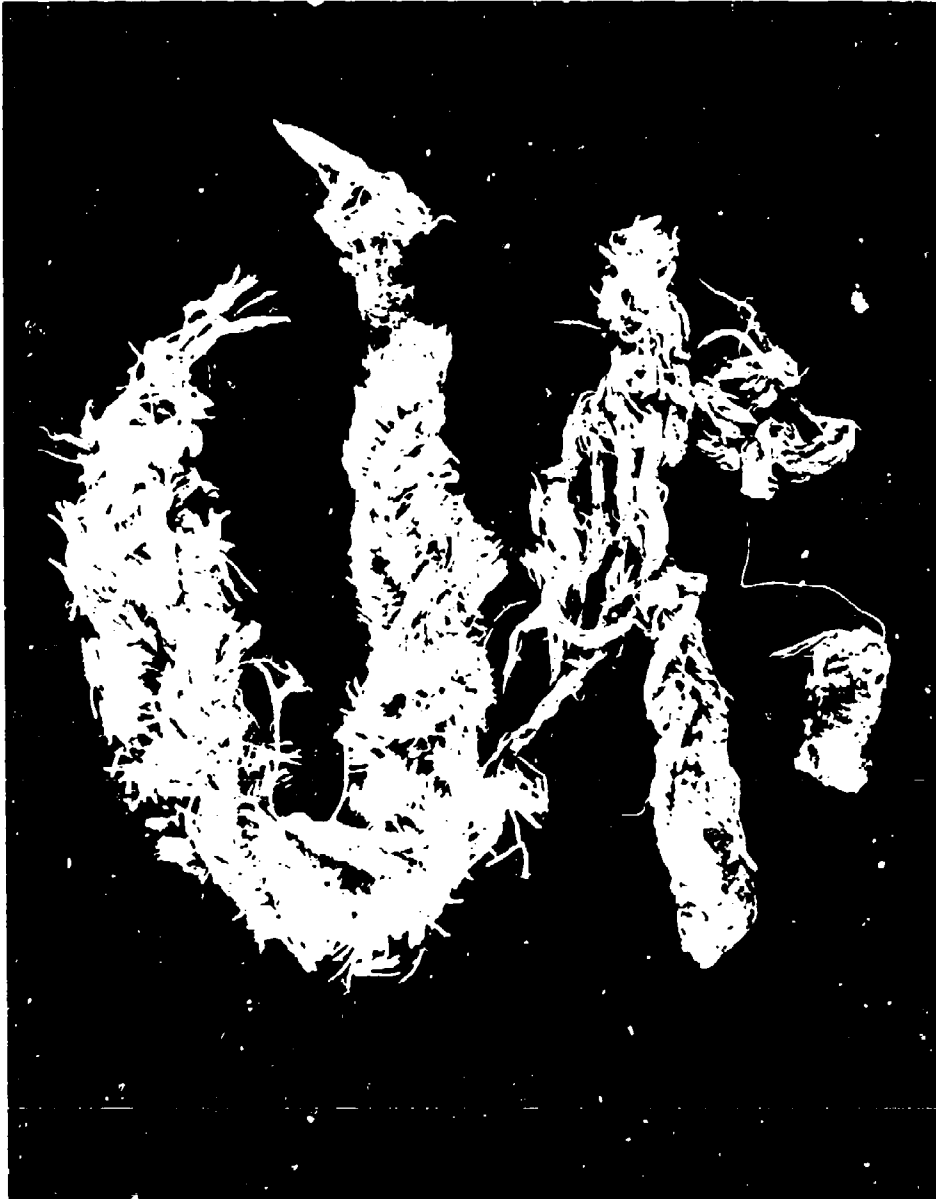
The recovered rope specimens (nylon, polyester, polypropylene, manila, and cotton) were covered with a layer of fine silt and some encrusting bryozoans. The fibers of manila and cotton ropes were deteriorated so severely by microorganisms that the fibers could easily be torn apart by one's fingers (Figure 6 and 7). The results of a tensile strength test conducted on the recovered synthetic ropes are presented in Table 2. The tensile strength of polyester, polypropylene, and nylon ropes decreased by 6.3, 9.5, and 19.7 percent, respectively. Data on tensile strength of manila and cotton ropes were not obtained since these had been severely deteriorated by biological activity. It is of interest to note that, although the tensile strength of polypropylene ropes had decreased when exposed in the bottom sediment, it had increased when such rope specimens were exposed in the deep-ocean environment (6000-ft depth).<sup>5</sup>

Figure 6. Cotton rope (1/2 inch diameter) fibers decayed by marine microorganisms after one year exposure.

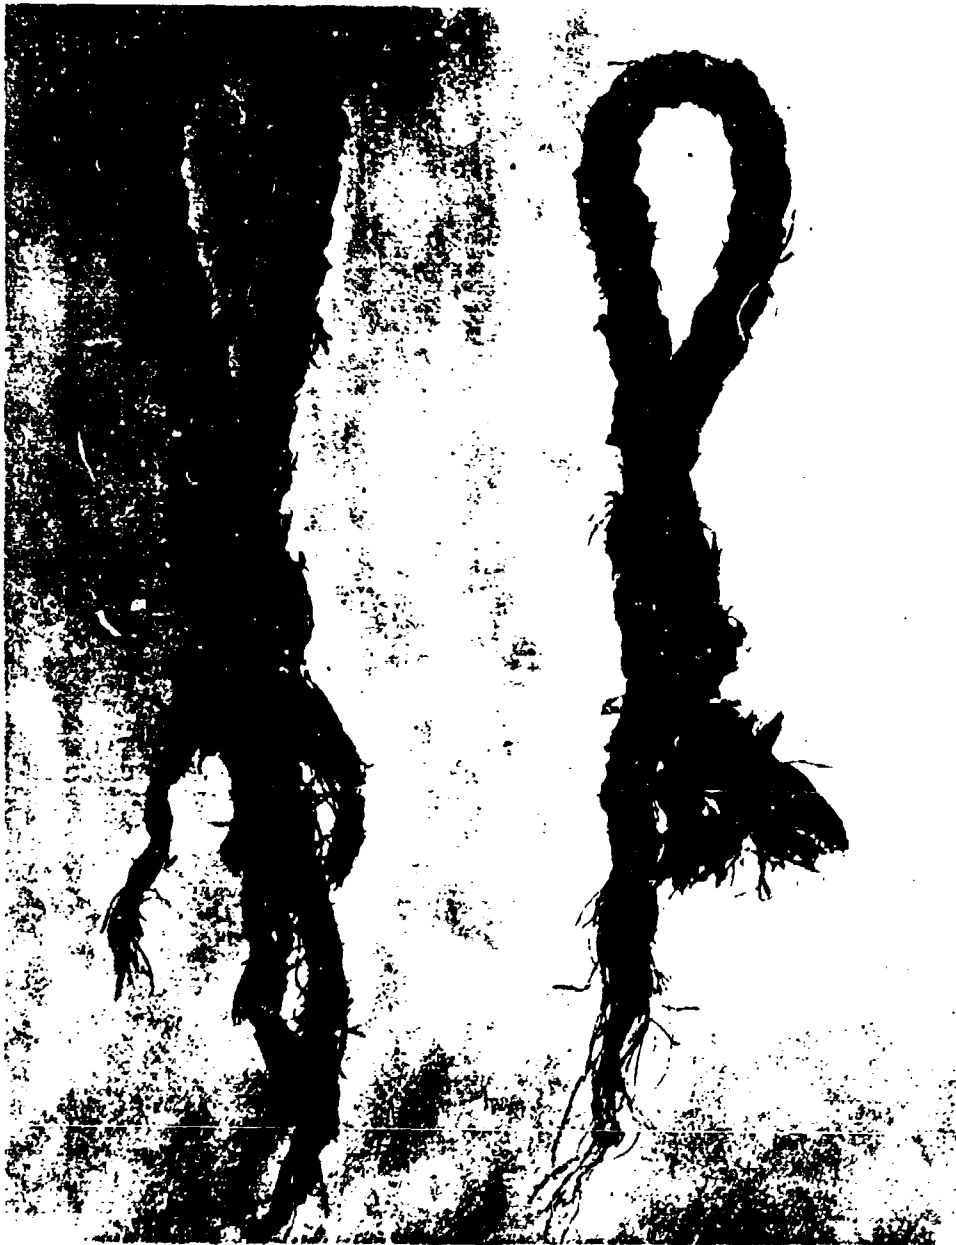
Figure 7. Manila rope (1/4 inch diameter) deteriorated by marine organisms after one year exposure.
